INVESTIGATION OF LATERAL VIBRATIONS IN TURBINE-GENERATOR UNIT 5 OF THE INGA 2 HYDROELECTRIC POWER PLANT

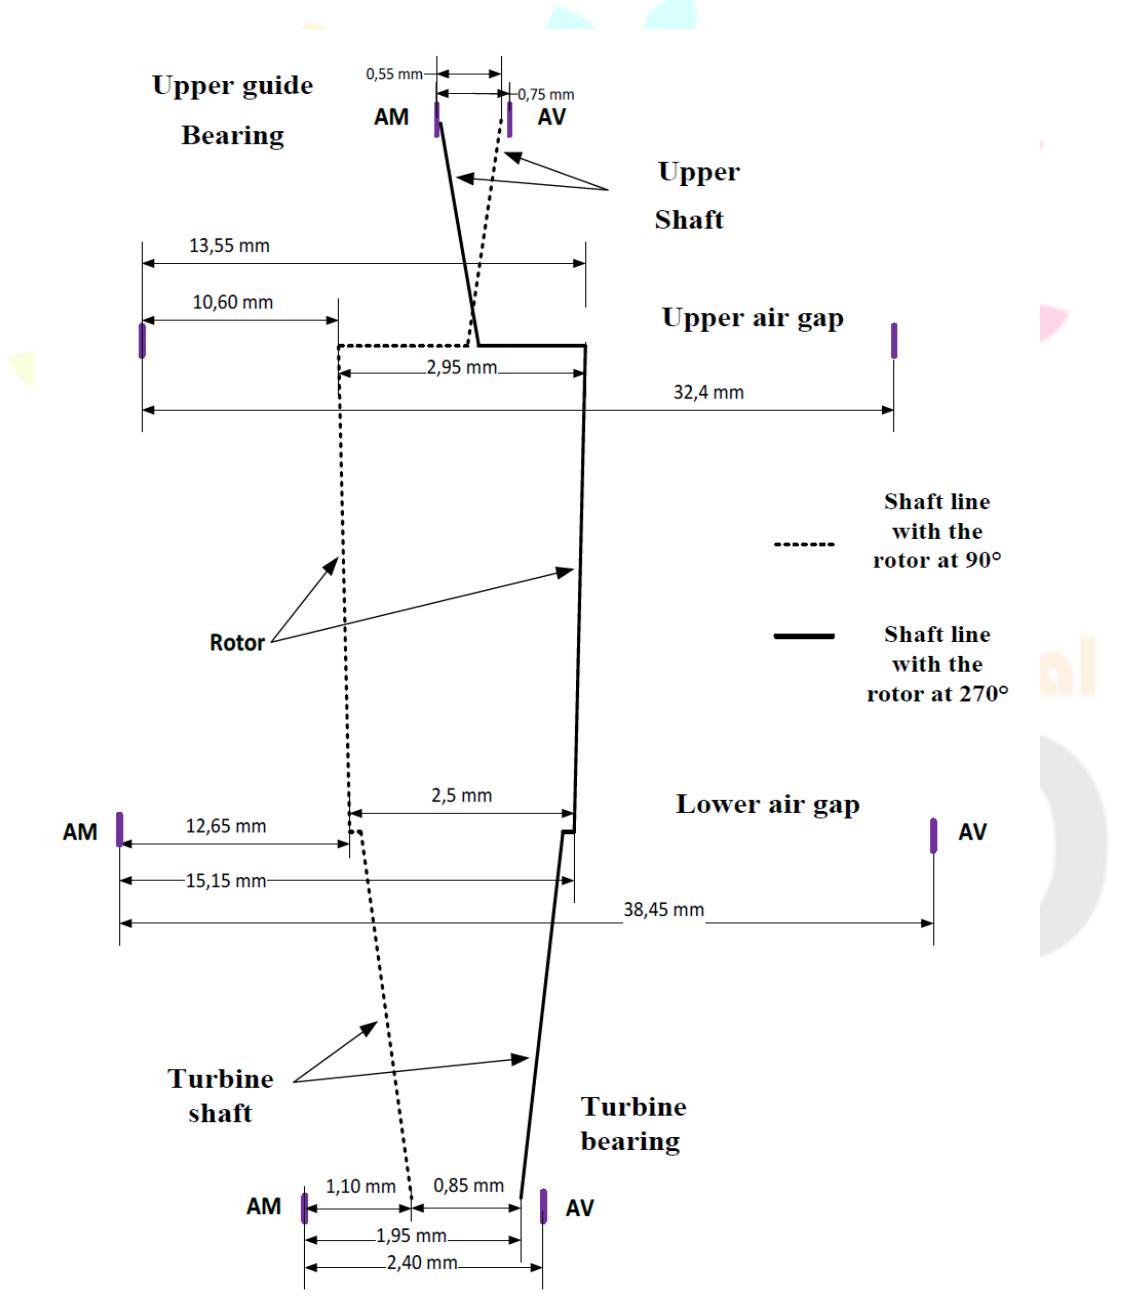
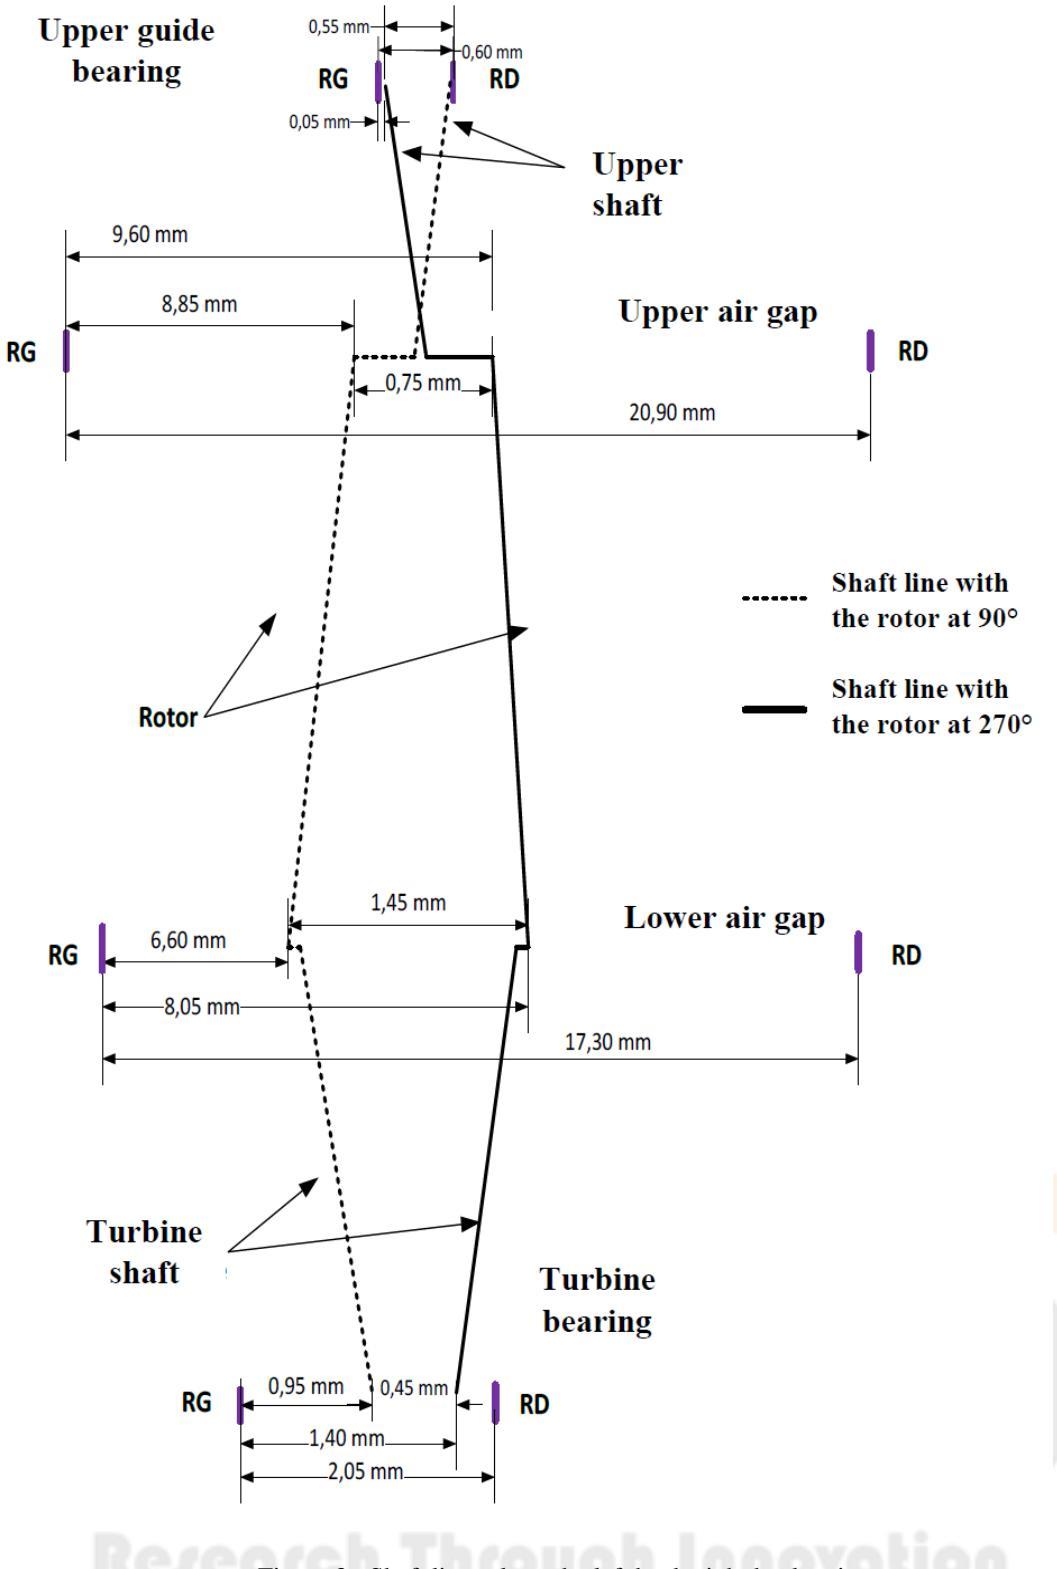
Figure 2 : Shaft lines along the upstream-downstream axis

Figure 3 : Shaft lines along the left bank-right bank axis

Based on the two presented graphs, the following phenomena were observed in the turbine-generator unit 5 at Inga 2; Shaft fractures in top shaft-rotor and turbine shaft-rotor couplings.

Strong eccentricity of the rotor axis in relation to the axis of rotation of the shaft line.

On these graphs, only the minimum values recorded on each measurement plane are shown, in order to illustrate the most unfavorable static positions of the shaft line.

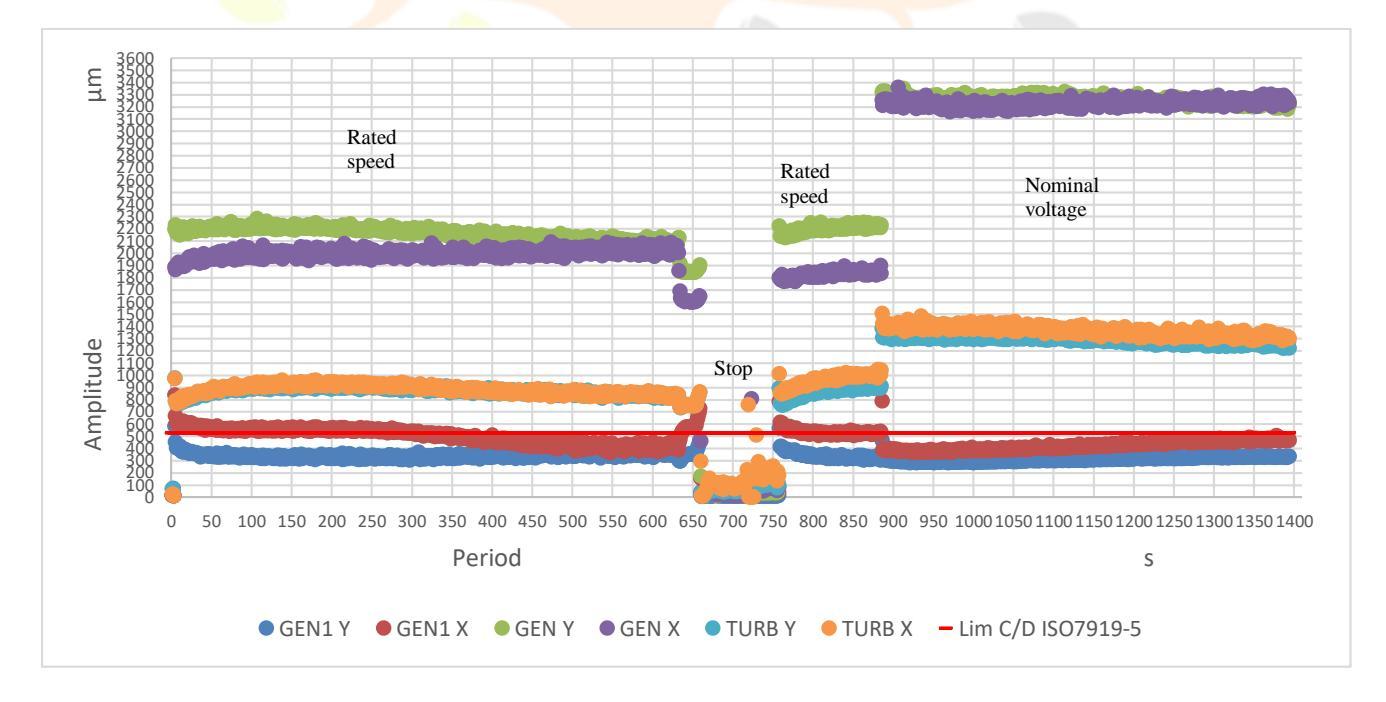
Figure 4 : Evolution (cloud) of the overall (peak-to-peak) displacements values for the last two tart-ups (06/07)

The nomimal voltage stage in the figure 4 has a larger amplitude value compared to the rated speed stage.
