Application of Spatial Technologies in the Maintenance of Water Distribution

¹Gabriel.P, ²Dr.Kazumb.S, ³Dr.Oberlin.A

¹Civil Engineer, ²Senior Lecturer, ³Senior Lecturer. ¹Department of Civil Engineering, Dar es salaam Institute of Technology. P.O. BOX 2958. Dar es salaam, Tanzania.

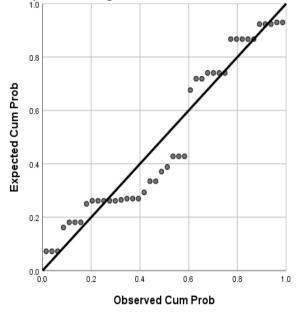
Figure 3.8 Trending Line for Multiple Regression

Normal P-P Plot of Regression Standardized Residual

Dependent Variable: Spatial technologies in the maintenance of water distribution network

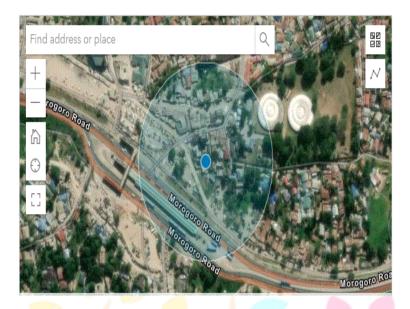
Figure 3.9.3: Show Pipe route

The tool for leakage and pipe replacement data collection is Survey 123 ArcGIS the window is indicated below figure 3.9.1, figure 3.9.2 and figure 3.9.3

Pipe route*

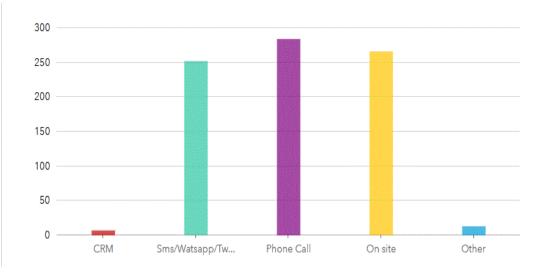
Figure 3.9.2: Graph source of information

The above graph show Figure 3.9.2 the number of leakages (non-revenue water) reported from different sources example ,the leaks that found on site tend to be 266 and phone call 284.sms/Twitter/Facebook 252,other 13 and CRM 7 of the total number (829) of non -revenue water reported .

The Table 3.9.2 for source of information below show the information of leakage (non-revenue water) from different sources example the leaks that reported by phone call tend to be high (34.26%) while on site tend to be (32.09%), watsup/sms/twitter /face book tend to be followed by (30.4%) and then minimum percent tend to be reported by other means of communication (1.57%) and CRM (0.84%) of whole non-revenue water (leaks) reported.

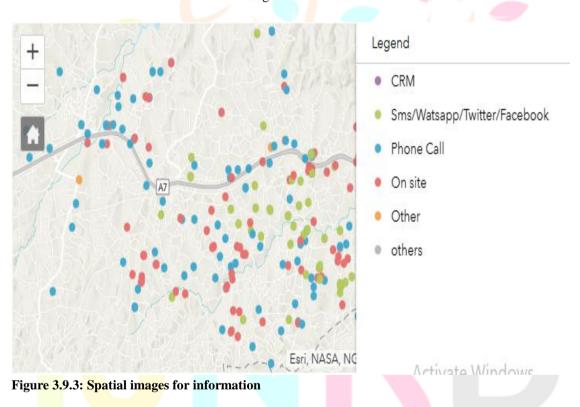
The below Figure 3.9.3 spatial image shows the distribution of different non-revenue water reported (leakage)in the Ubungo regional.

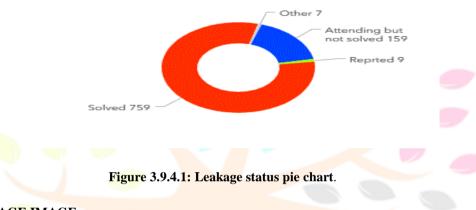
LEAKAGE STATUS PIE CHART

The Table 3.9.4.1 and Figure 3.9.4.1 shows the status of leakage control (non-revenue water) the leakage repaired (Solved) tend to be 79.73% while attending but not solved (that means the problem are either partially or not solved completely but the responsible personnel knows the problem well) the reported leaks tend to be 18.46% and the leakage reported only but not well known by the responsible personnel tend to be 0.97%

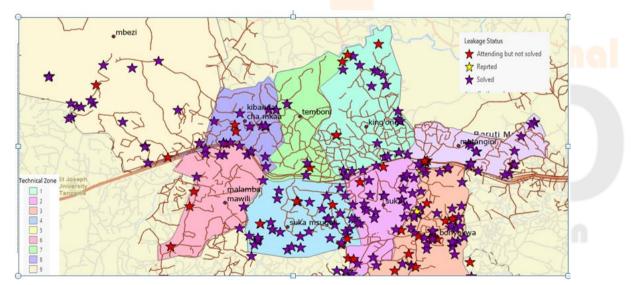
Figure 3.9.4.2 Spatial image leakages

The Figure 3.9.4.2 Spatial image shows how the leakage is distributed in different zones along the water pipe network by status (reported, attending but not solved and solved).

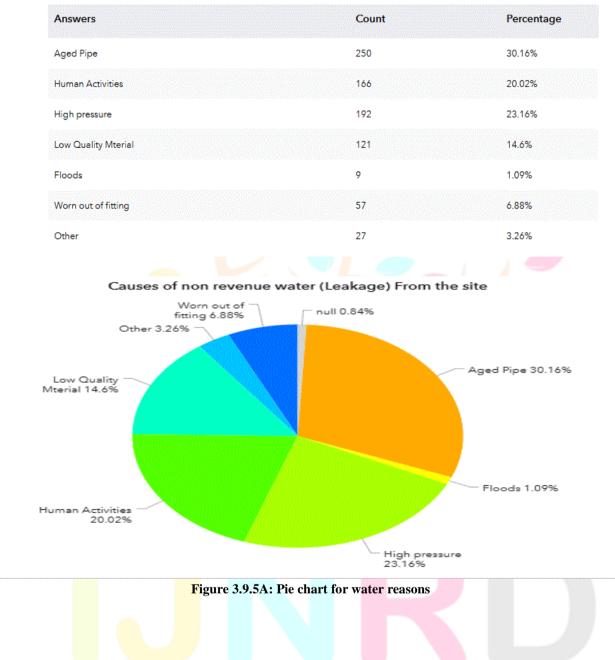
The Table 3.9.5, Figure 3.9.5A and Figure 3.9.5.B an: above shows the different causes of leakage at particular area (zone) example most of the leakages tend to be caused by the aged pipe which tend to have 250 leaks, followed by high pressure which count 192 while human activities 166 followed by low quality of material which count 121, worn out of fittings 57, other 27 and floods tend to count 9and.

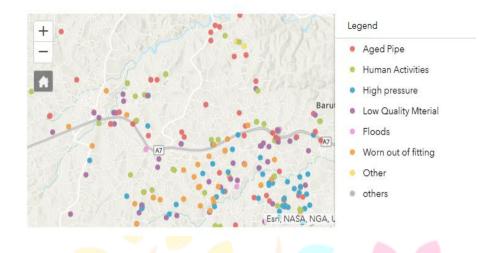
Figure <mark>3.9.5.B:</mark> Spatial image for leaks reasons

SPATIAL IMAGE OF LEAKS REASONS

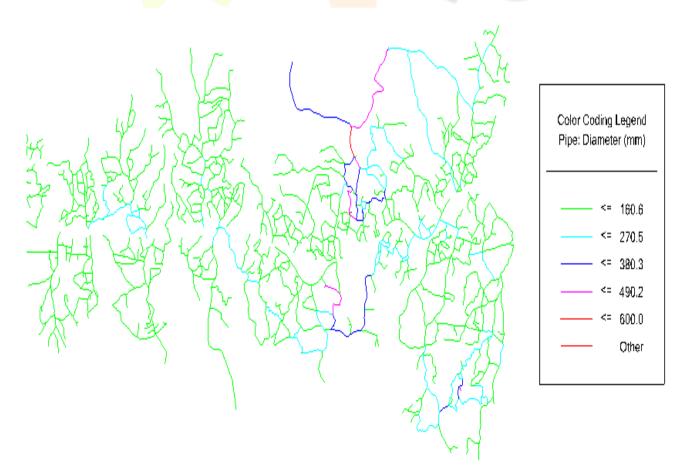
Figure 3.9.5C: Simulation of the water network

The simulation of the water project which was done by using waterGems software tend to show the result as shown above in which the pressure tends to be 2bars in diameter of 174.9mm (6") during the operation

Pressure results were obtained as shown on the Table 3.9.5BC below, by 19 May 2023 the pressure tended to be higher as the results the pipe tended to leaks at the joint in which male and female pipe joined

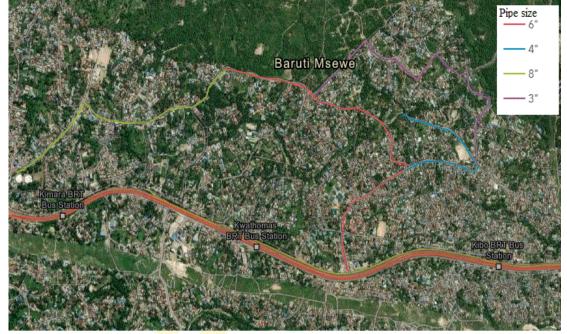
Figure 4.0.2: Proposed pipe spatial replacement map

The Table 4.0 and Figure 4.0 below shows the data collected and spatial distribution for pipe replacement for planning in which (44.44%) of 6" pipe size of PVC class C where 22.22% of 4", 8" of 22.22% and then followed by 3" of which tend to have 11/11%.

Proposed pipe spatial replacement map

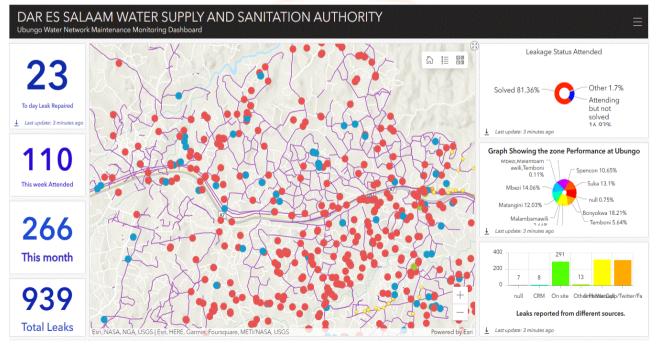
Figure 4.1: Dashboard for leakage control activities.

The Ubungo Regional Dashboard Leakage Dashboard Figure 4.3.0 enables staff to monitor solved leaks, attending but not solved and other by day, week, month, or year as well as repairs in zonal wise. Dashboards are also used to understand leakages per pipe diameter, material, and location.

ArcGIS Dashboards is used to create dashboards that manage the work and visualize data being collected. The progress of inspections is easily tracked, providing a view of leakage status. Ubungo Regional can quickly identify the areas or zones with many leakages with the reason causes.

The use of dashboards has raised awareness among staff and improved operation and maintenance management of daily operations. Engineers and other staff are able to access dashboards using their smart phones and desktop or personal computers.
