Analysis of the impact of Brahmaputra riverbank erosion on agricultural productivity and riverine communities in Assam

Ravi Kant

B.A. (Hons.) Geography

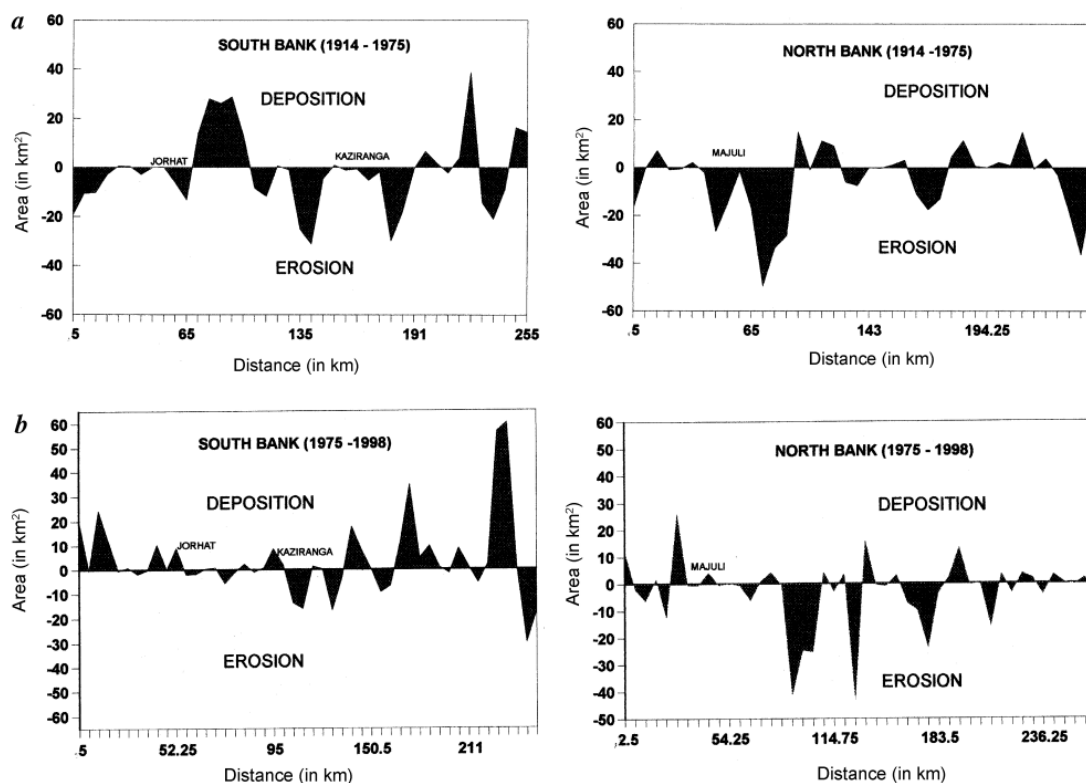
Image: Erosion and deposition in the studied reach of the Brahmaputra River channel during (a) 1914–75 and (b) 1975–98. *Source: Current Science · February 2005*

The processes of deposition and erosion that took place between 1974 and 1975 and between 1975 and 1998 could not be compared. There were indications of considerable erosion on both riverbanks in the study area between 1914 and 1975. The greatest deposition, however, was discovered across a 30-kilometer stretch along the river's southern bank; it covered 28.15 km² of soil near Sikarighat and peaked at 38.75 km² close to Bhomoraguri Hills. The areas known as Jorhat-Majuli are the most noticeable along the 50 km of erosive activity that precede Kumargaon. A total of 49.5 km² of land had been lost in this area. Furthermore, there was significant erosion in the region from Sohola Bil to Dipholumukh that surrounded Kaziranga National Park. Up to 1975, 83.23 km² of this region were lost to erosion from the main mass. It is interesting to note that the banks of the Brahmaputra have severe erosion from Orang Reserve Forest to Haloukonda Bil. But between 1914 and 1975, there was a discernible increase in erosion on the northern bank of the river compared to the southern side. There is a minor variation in the circumstances from 1975–98 compared to the previous investigative era (1914–75). A change in location has resulted in a small decrease in the amount of erosion in the Majuli area. Along its southern bank, the river showed signs of a depositional phase close to Kaziranga National Park and Neemati-Jorhat. An additional 17.65 km² was added to the southern bank of the Brahmaputra in Kaziranga, close to the confluence of the Burai River.

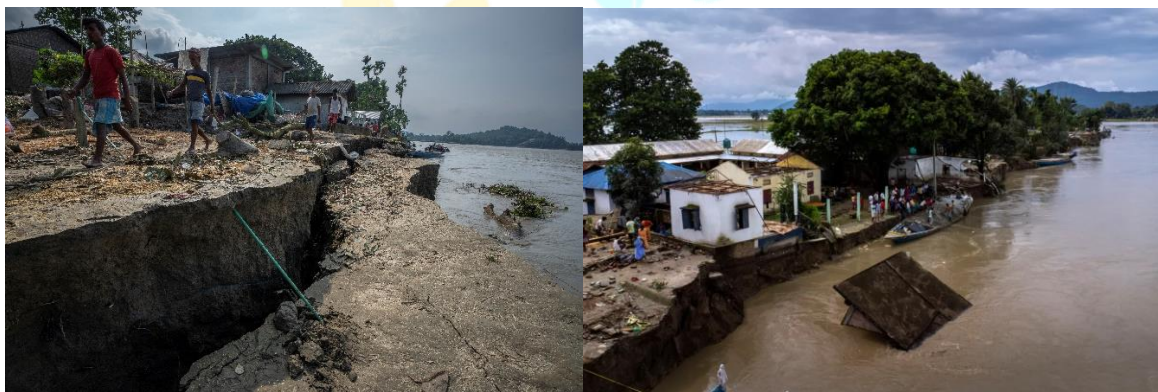
Image (a): Bowl shaped erosion by the river in Murkata village

Image (b): Village temple and homes being washed *Source: Al Jazeera, 7 Nov 2022*
