# AN ASSESSMENT OF FLOOD AND ITS IMPACT ON HUMAN SOCIETY: A CASE STUDY AT KANDI BLOCK, MURSHIDABAD

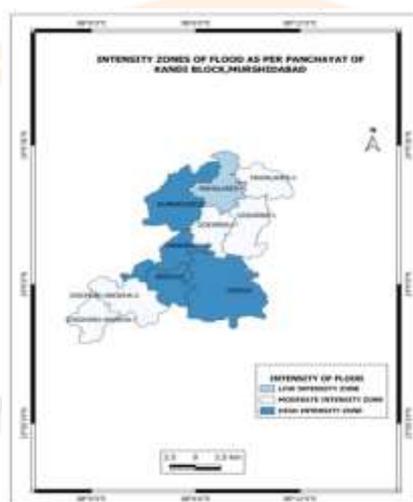
Fig-2: Flood Intensity Zones of Kandi Block

Basically this place is inundated in the time of rainy season. Although all the administrative areas are more or less flood effected but the quantity of inundation is not same for all the areas of this block. According to the severity of flood, there are shown three zones of the of the flood prone areas, one is high intensity zone, another is moderate intensity zone and last one is low intensity zone (fig-2). Furthermore it has been compared the extent of flood with total are as per panchayat (TABLE - 1 ) and presented graphically the extent of flooded area to total area as per panchayat of 2015 of this block (fig-3) as well.

The extent of flooding in the areas covered by this zone is higher than all other areas of this block. The names of the panchayats of this zone are- Hizole, Andulia, Purandarpur and Kumarsanda.

The extent of flooding in the areas under this zone is lower than high intensity zone. The panchayats' names are- Gokarna-i, Gokarna-ii, Mahalandi-ii, Jashohori Anukha-I, Jashohori Anukha-ii.

The area under this zone is not much affected by flood. The panchayat is mahalandi-i.

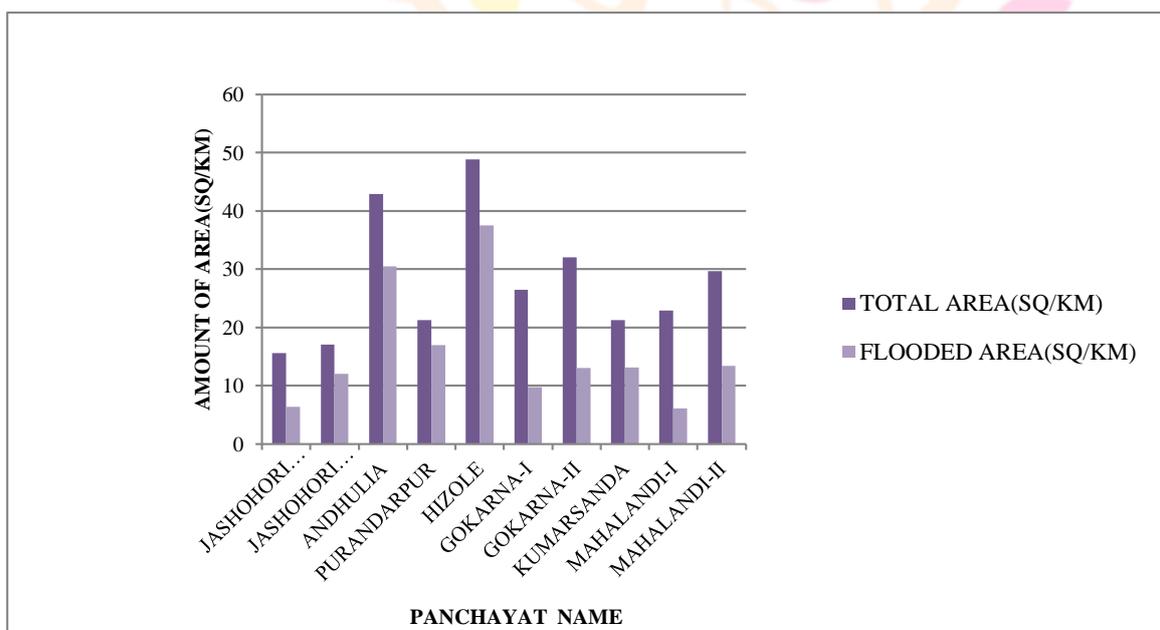
**Fig-3: Bar Diagram**  
Showing the Extent of Flooded Area to Total Area as Per Panchayat (2015)

Sl No	Place	Total Area(Sq/Km)	Flooded Area(Sq/Km)	Flooded Area (%)
1	Jashohori Anukha-I	15.59	6.31	43.2488
2	Jashohori Anukha-Ii	17.07	12.03	66.55607
3	Andulia	42.91	30.46	73.81609
4	Purandarpur	21.22	16.93	78.78338
5	Hizole	48.89	37.52	83.58209
6	Gokarna-i	26.48	9.75	44.37311
7	Gokarna-ii	32.07	12.99	43.1992
8	Kumarsanda	21.29	13.11	61.57821
9	Mahalandi-i	22.92	6.04	26.352523
10	Mahalandi-ii	29.67	13.37	57.33276

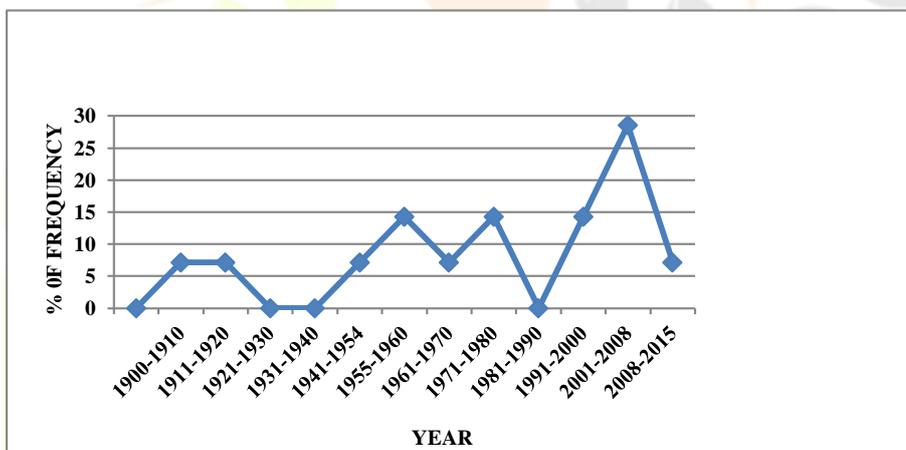
**Fig- 4: Trend of Percentage of Flood Frequency (1900-2015)**

Range Of Time	Flood Frequency	
	Frequency	% Of Frequency
1900-1910	1	7.14
1911-1920	1	7.14
1921-1930	N.A	N.A
1931-1940	N.A	N.A
1941-1954	1	7.14
1955-1960	2	14.28
1961-1970	1	7.14
1971-1980	2	14.28
1981-1990	N.A	N.A
1991-2000	2	14.28
2001-2008	4	28.56
2008-2015	1	7.14

Flood such a natural hazard that basically occurs for rain. Having said that, there are so many human interferences behind it. History depicts (table-2) that the kandi block is experiencing this condition from long time. Through the graphical presentation (fig-4) it can see that the trends of percentage of flood frequency (1900-2015). There are some specific reasons behind it. With the previous evidences of here the reasons can be divided into two, one is natural reasons and another one is anthropogenic reasons.

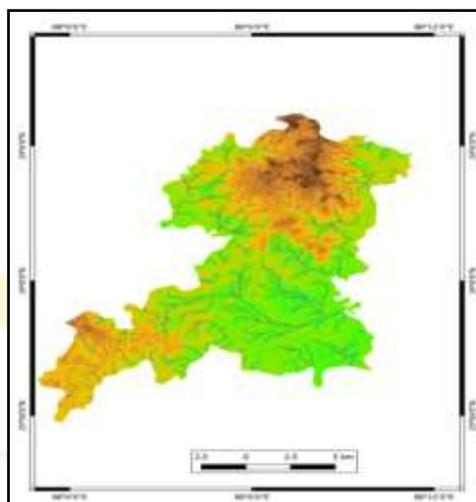
**Fig-5: Drainage System of Kandi Block**

It has been observed that most of the part of kandi block, specially the south eastern part, is suffering under poor drainage (fig-5). Large number of rivers likes mor, beli or tengramari, kuye, banki etc. have concentrated in hizole beel and influxes with dwarka river within very short range of space. It should also be mentioned that dwarka river before interception of these rivers has conceived some other

significant rivers just north of kandi block. So, in general situation, dwarka itself becomes brimful with its own huge volume of water as well as it has not any further ability to carry out any extra water debouched by the tributaries. Moreover, large number of river segments have spaced interwovenly in the confluence zone of mayurakshi - kuya river in such a fashion that no one could find their paths due to abyssal submergence by monsoonal water.

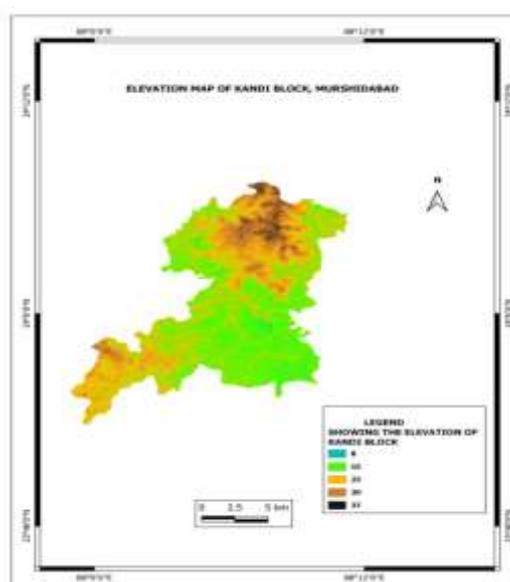
**Fig-6 Elevation Map of Kandi Block**

Average slope of this region is 0.19 m. Per 1 km, which is further reasonably low in the south eastern part of this block. Due to such poor physiographic slope (fig-6) swift water movement is beyond expectation. There are no significant slope & relief differences and the water pressure during monsoon is much stronger in the tributaries. So from this information, inference can easily be drawn out that the parent stream dwaraka has not ability to carry the combined discharges of the tributaries which is about 25% greater than Master River. So, it is highly responsible for inundation.

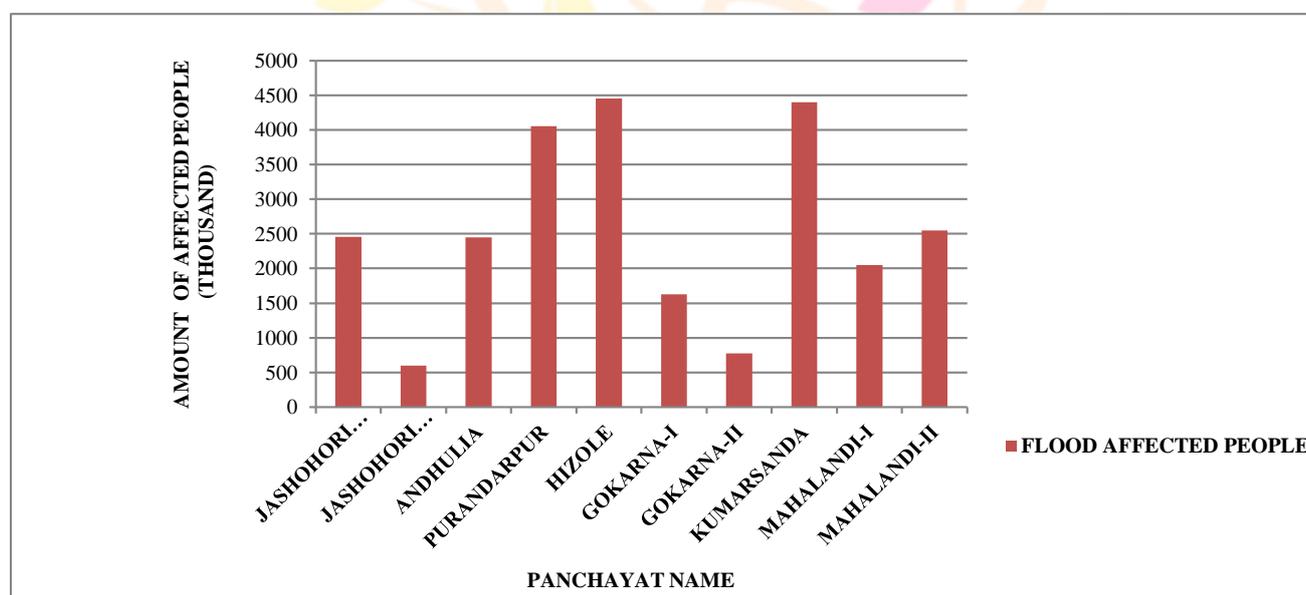
**Fig-7: Bar Diagram**  
**Showing the Extent of Affected People as Per Panchayat (2015)**

Sl No	Name Of The Gram Panchayat	No Of Flood Centre	Flood Affected People
1	Jashohori Anukha-I	16	2460
2	Jashohori Anukha-Ii	8	600
3	Andulia	13	2450
4	Purandarpur	18	4050
5	Hizole	15	4450
6	Gokarna-I	5	1625
7	Gokarna-II	3	775
8	Kumarsanda	16	4400
9	Mahalandi-II	9	2050
10	Mahalandi-II	13	2550

The kandi block is flooded in the rainy season with more or less all mouzas. The human society is badly affected during the flood but here one evidence is presented of the year 2015 (TABLE-3). We can see in the previous mentioned year the quantity of vulnerable people as per panchayat graphically (Fig-7). There is shown vulnerable situation on many fields, like- socio-economic, communication etc.
