DESIGN OF ANGANWADI BUILDING

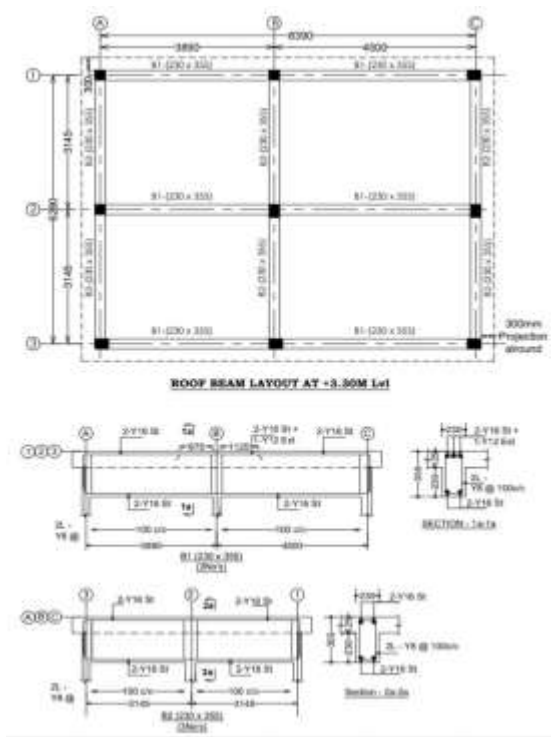
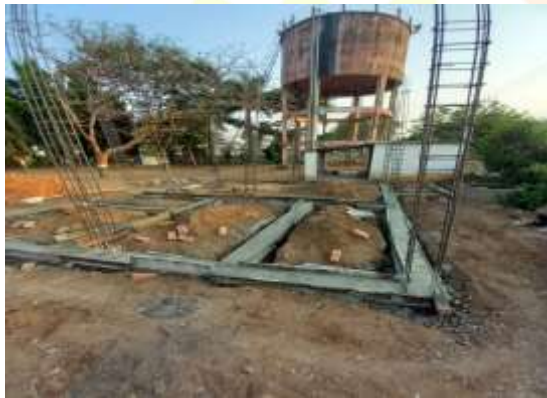
- bending moments.
- Concrete: M25 (likely, standard for govt. buildings)
- Steel: Fe500
- Safe in bending and shear as adequate main and stirrup steel is provided.

- Designed for a roof slab, thus carrying mostly dead load + roof live load (minimal compared to floor live load).
- Columns are short axially loaded.
- Safe for assumed loads (around 800–1000 kN), given the % reinforcement and concrete grade (likely M25).

- Designed with standard confinement ties → safe in shear and buckling.
- Safe bearing pressure is 175 kN/m².
- Sizes and reinforcements are adequate for column loads (~800–1000 kN).

- Flat footings designed as isolated footings with adequate depth and steel.
- Transfers column load to footing effectively.
- Reinforcement ensures axial compression capacity.

- Designed as tie beams connecting columns at plinth level.
- Reinforcement is typical for spans ~3.0–4.5 m and loads from wall and slab above.
