ASSESSMENT OF TECHNICAL EFFICACY AND ECONOMIC IMPACTS OF BENCH TERRACES IN SOIL EROSION CONTROL FOCUS ON GREEN GICUMBI PROJECT, GICUMBI DISTRICT

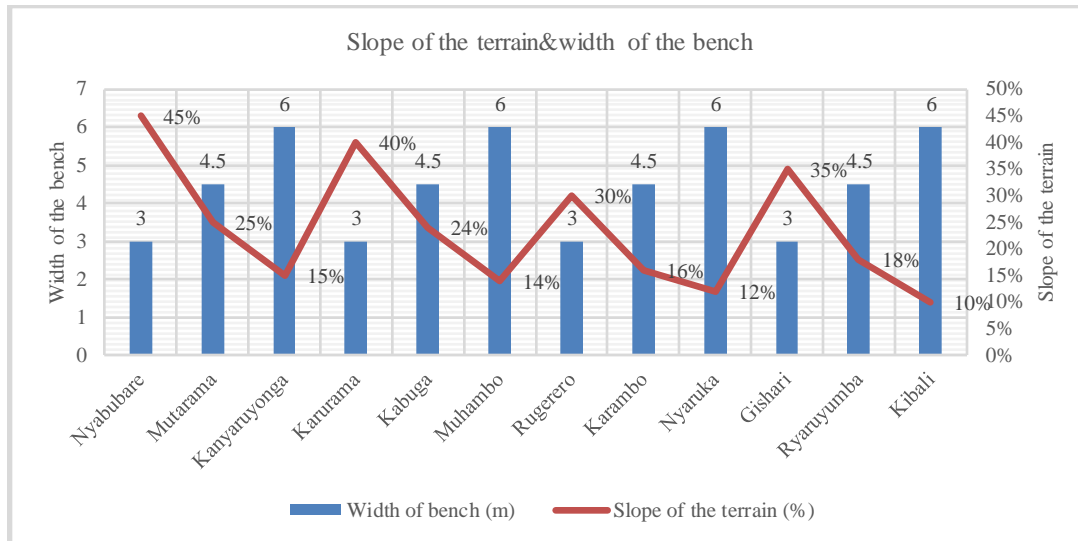
Figure 3: Assessment of land use change in Bahimba wetland

Figure 3 shows that the technical design parameters of bench terraces across twelve Green Gicumbi Project sites generally align well with FAO recommendations, with most measurements falling within acceptable ranges. Vertical intervals (VI) and bench widths closely match the standards, though some sites show slight variations likely due to local slope conditions or construction limitations. Riser heights and slopes vary more widely, with some exceeding typical guidelines, which could increase erosion risks if not properly stabilized. Bed slopes remain gentle and within safe limits to control runoff. Overall, the terraces are technically sound and effective, with minor site-specific adaptations that do not significantly affect their functionality, though steeper risers may require additional stabilization for long-term durability.

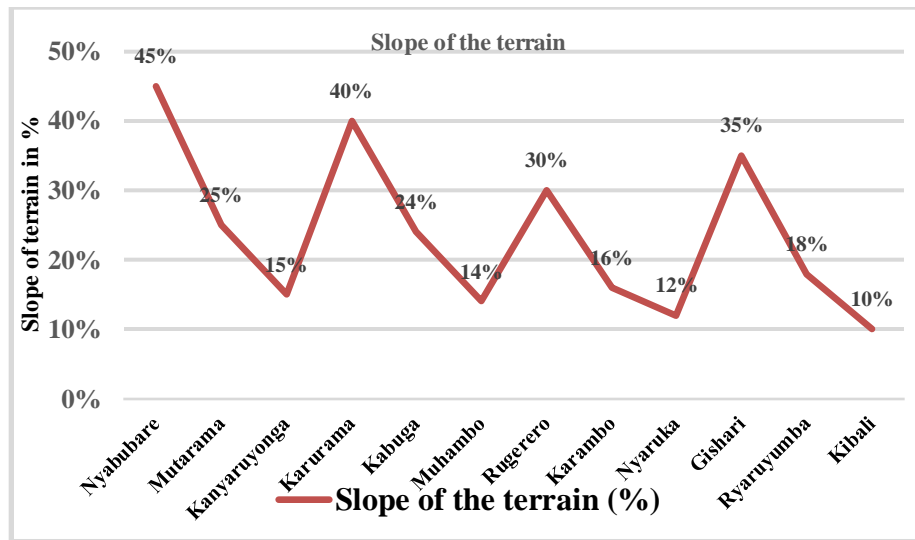
Figure 4: Slope of the bench terraces site, Primary data 2025

According to FAO guidelines, the suitability and design of bench terraces depend heavily on the degree of slope, with general recommendations as follows: From the figure 18 provided, the terrain slopes across the 12 sites range from 10% to 45%, showing a diversity of conditions: Gentle slope sites: Kibali (10%) and Nyaruka (12%) ideal for broad-based terraces that support crop cultivation with minimal erosion risk. Moderate slope sites: Karurama (15%), Muhambo (14%), Karambo (16%), Rugerero (30%), Ryaryuyumba (18%) suitable for narrow-based terraces with moderate investment in stabilization. Steep slope sites: Gishari (35%), Kabuga (40%), Kanyaryuyonga (25%), Nyabubare (45%) these require strong erosion control measures, such as reinforced risers, drainage channels, and possibly vegetative stabilization.

This distribution confirms that bench terraces were implemented across a wide range of terrain gradients, and according to FAO recommendations, steeper areas demand more technical precision and structural reinforcement to ensure long-term functionality and resistance to erosion. Therefore, the construction of terraces in the Green Gicumbi Project appears to be aligned with FAO best practices, demonstrating both technical feasibility and adaptability to varied topographical conditions.

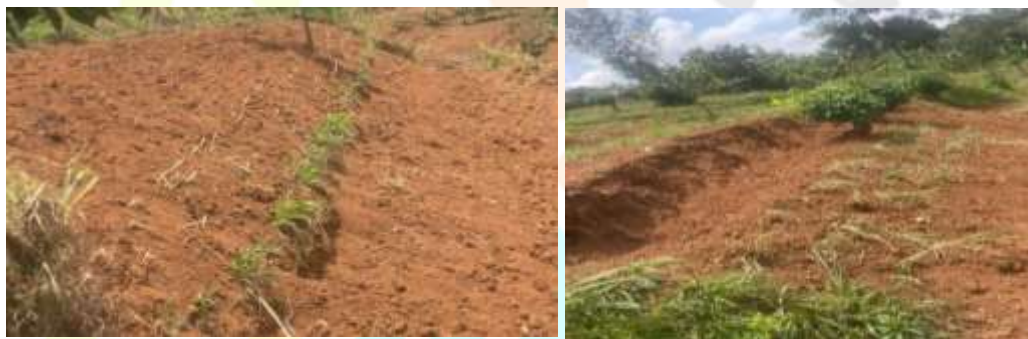
Figure 5: Destruction of embankment to increase cultivable area, Primary data,2025

Field observations (Figure 5) and Focus Group Discussions (FGDs) revealed that some farmers, particularly those less familiar with the Green Gicumbi Project interventions, have engaged in the destruction of bench terrace embankments. Driven by the desire to expand cultivable land, these farmers perceive the embankments as occupying potentially productive areas. However, this practice severely compromises the integrity and functionality of the terraces, leading to increased soil erosion, reduced water retention, and eventual land degradation.

This issue was especially prevalent among farmers who had limited participation in terrace construction, maintenance training, or awareness programs. Many of them, including newly resettled farmers and those with minimal exposure to project activities, lacked understanding of the importance of the terraces in promoting sustainable land management.
