INTEGRATION OF SMART SENSOR NETWORKS AND VISION-BASED ANALYSIS FOR REALTIME CONSTRUCTION QUALITY MANAGEMENT

¹MR. SHWETA R. BANTEY, ²DR. AMIT B. RANIT, ³PROF TEJASWINI D. KADAM

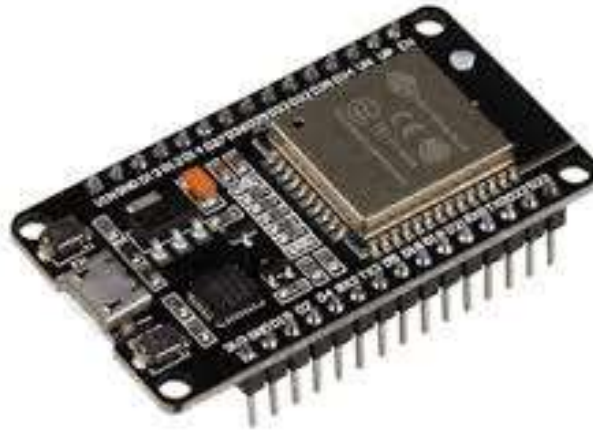
The core of the IoT node is the ESP32 microcontroller, selected for its dual-core 240 MHz architecture, integrated Wi-Fi capabilities, and low-power operation. Structural vibration is measured using the MPU6050 six-axis MEMS IMU, configured for a $\pm 2g$ range yielding high resolution (0.61 mg/LSB). Readings are converted into m/s^2 units for compliance with ISO 2631-1. Ambient temperature

is captured via the DHT22 sensor, while concrete moisture is monitored using a capacitive moisture probe, which calculates the dielectric constant variations of the material.

Fig. 1. ESP32 Microcontroller Node Architecture.

The firmware, developed in C++ using the Arduino IDE, establishes a strictly non-blocking architecture ensuring simultaneous data acquisition, processing, and communication. The firmware handles dual I2C buses (Wire and Wire1) to accommodate four MPU6050 sensors simultaneously, bypassing I2C address conflicts.

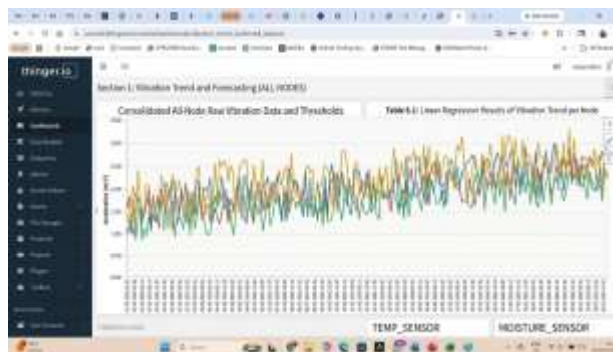
The system achieved a 99.8% data transmission success rate with a mean MQTT latency of 185 ms over a 4G LTE connection. The data was visualized in real-time using Thingier.io dashboards.

Fig. 3. Thingier.io Dashboard - Vibration Trend Analysis.

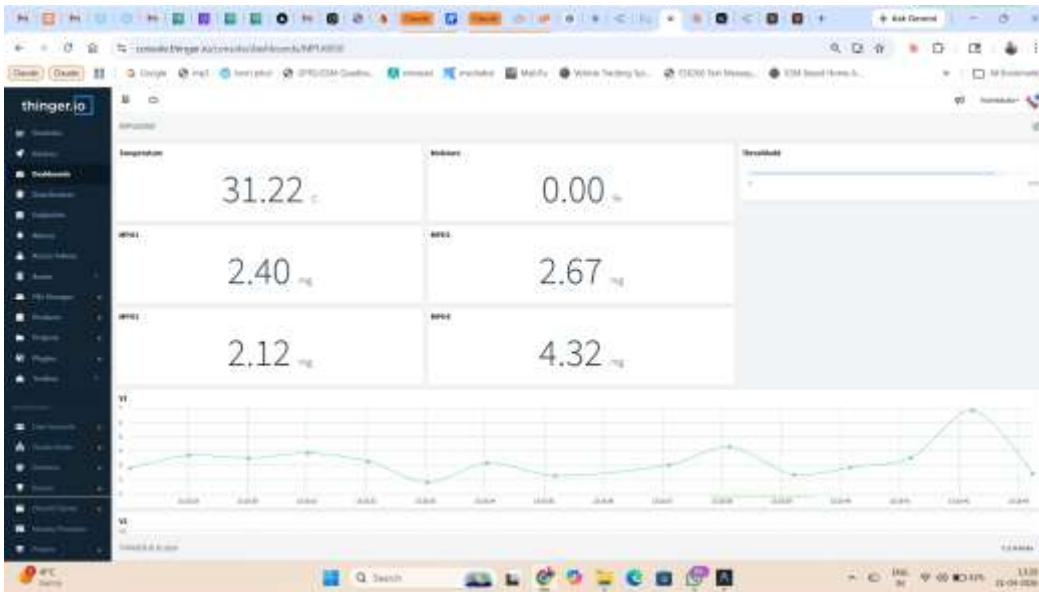
Vibration readings across the nodes established baseline normative behaviors, with the North node experiencing the highest mean vibration (1.87 m/s^2) due to prevailing wind dynamic loading. Linear regression analysis identified a statistically significant positive vibration trend ($+0.0048 \text{ m/s}^2$ per day), signifying cumulative stress unseen by manual inspection. Temperature readings highlighted expected diurnal cycling (28°C to 42°C), inversely correlating with capacitive moisture readings (8.2% to 17.8%). Multiple linear regression confirmed that vibration variance was dominated by mechanical loading rather than thermal expansion.

Fig. 6. Vibration Descriptive Statistics by Node.

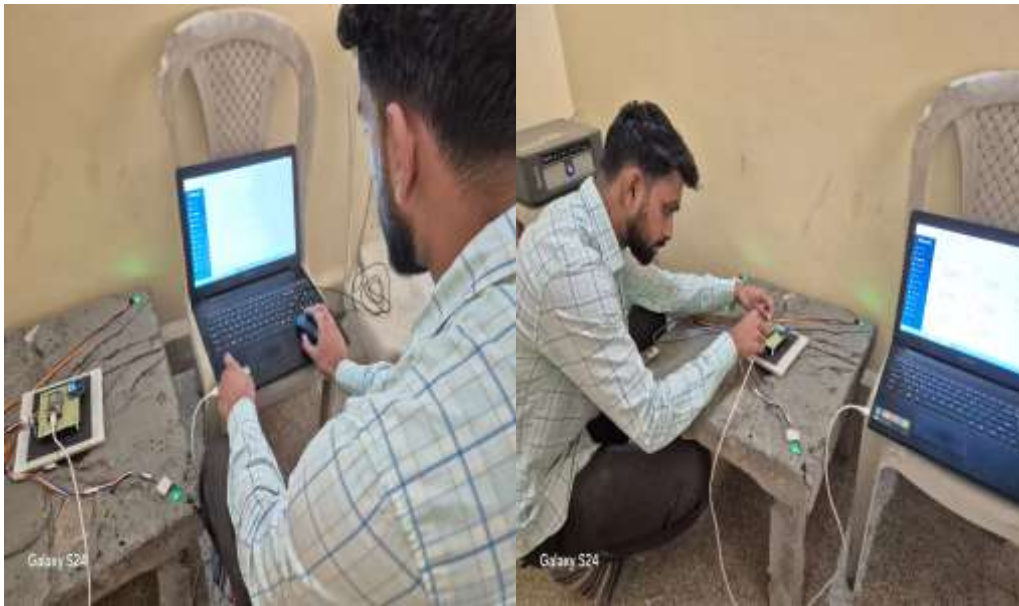
Fig. 7. Real Time Monitoring .

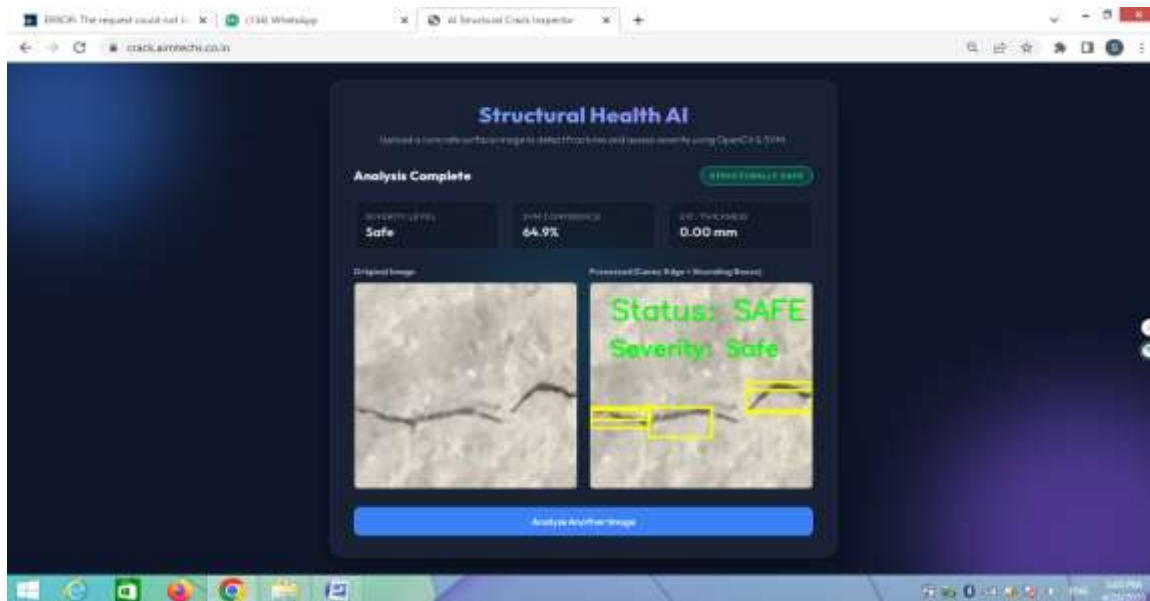
Drone imagery underwent preprocessing via OpenCV (Canny Edge Detection and Contour Mapping) before classification by the VGG16 CNN. The AI model, optimized using transfer learning on the Concrete Crack Images dataset, achieved an accuracy of 99.2%, precision of 98.8%, and recall of 99.1%. Structural anomalies were rapidly enclosed in visual bounding boxes and delivered to site engineers in tandem with IoT telemetry data.

Fig. 10. Cracks Detection and Contour Mapping

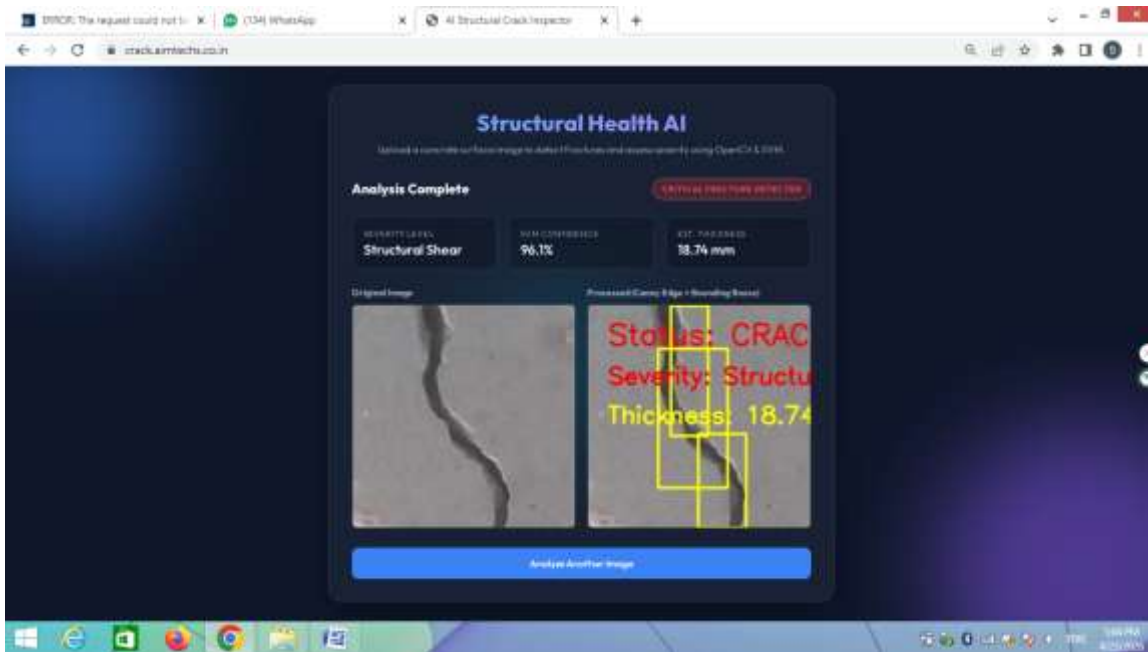
Fig. 11. Vision-Based Concrete Crack Detection with Bounding Box Localization
