EARLIEST DEDUCTION OF INTERNAL CRACKS OF REINFORECED CONCRETE WITH SILICA FUME BY USING FIBRE OPTIC CABLE

ASWINTH S
DINESH M S
PRASANNA S
NAVIN V
SHREE NAVEEN J B

SRI SHAKTHI INSTITUTE OF ENGINEERING AND TECHNOLOGY

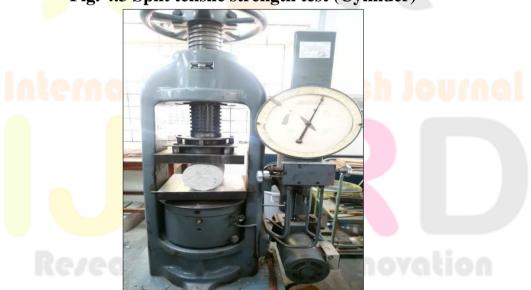
Fig. 4.3 Split tensile strength test (Cylinder)

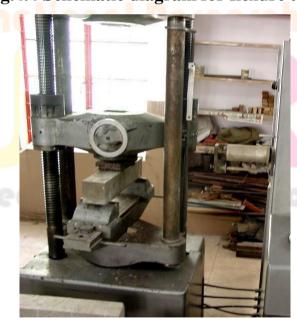
Fig.4.5 Flexural strength test

As explained earlier, in the present investigation, the flexural strength test has been conducted on concretes with different type of coarse aggregate M25 grade of silica fume concrete silica fume concrete.at 7,14 and 28 days.

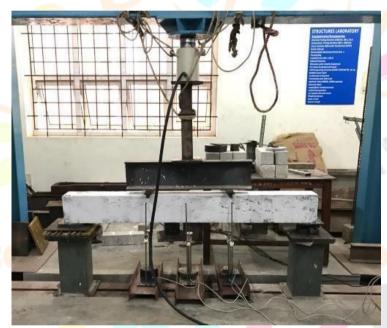
Fig. 4.8 RC Beam Test
