INVESTIGATION OF LATERAL VIBRATIONS IN TURBINE-GENERATOR UNIT 5 OF THE INGA 2 HYDROELECTRIC POWER PLANT

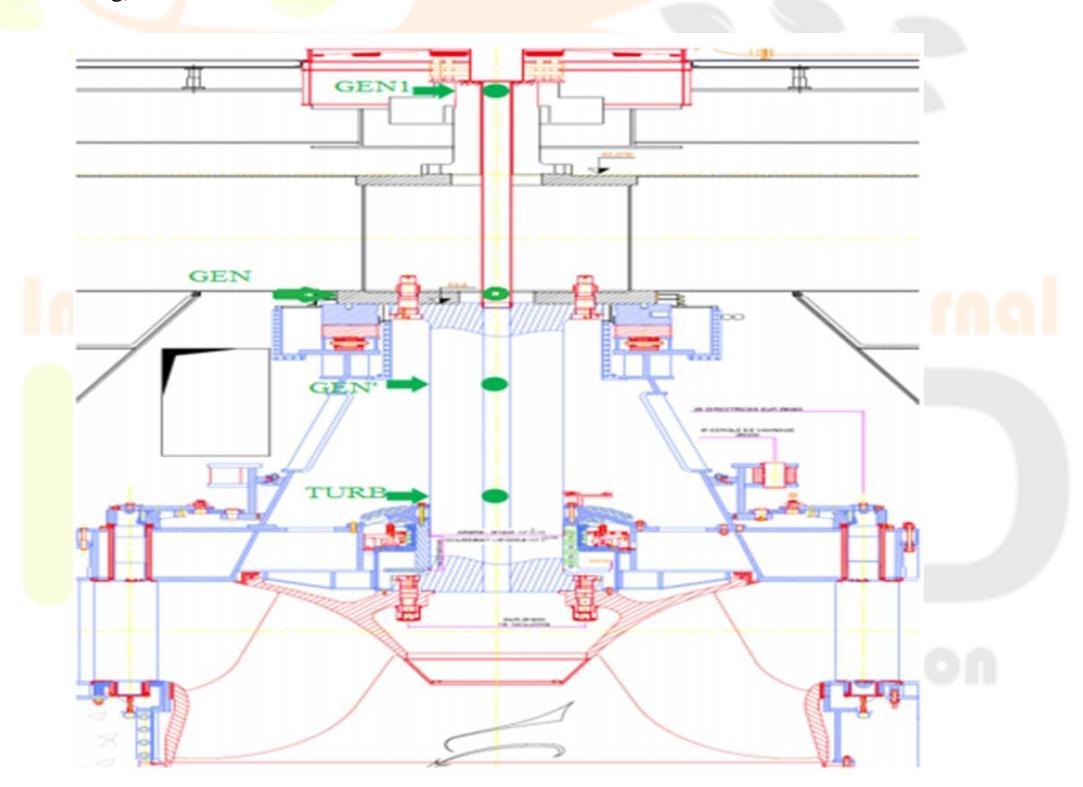
Figure 1 : Sensor location on each measurement plane (Revue ACEC, 1982)

Using four measurement planes to record lateral displacements of the shaft line using proximity probes in hydroelectric group 5 (Figure 1), namely;

Plane 01 (upper guide bearing): GEN1.

Plane 02 (Pivot/Rotor): GEN.

Plane 02' (Pivot/shaft): GEN'.

Plane 03 (lower guide bearing): TURB.
